DOT/FAA/AR-95/49

A Study of the Continued Fire Worthiness of Aircraft Seat Cushion Fire-Blocking Layers

March 1997

Final Report

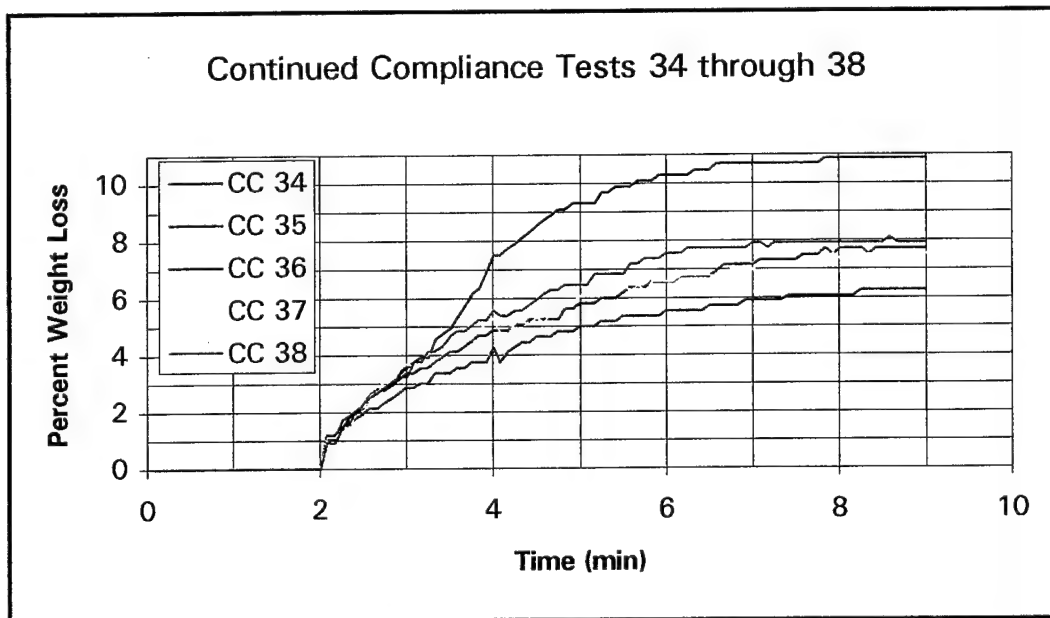
FIGURE 9. PERCENT WEIGHT LOSS PROFILES, TESTS 34 THROUGH 38

The percent weight loss was 10.87 for test number 36. This test was one of the final four tests performed which had reused vertical cushions. In review of this test, the final weight loss was mainly affected by the involvement of the reused vertical cushion. Had the vertical cushion been in an untested condition, the entire cushion set would have been expected to pass in the same manner as the other 29 tests.
